**April 2000**

# MAINTENANCE BULLETIN

**Alfa Company**

SUBJECT: Troubleshooting and Repair of Serpentine Belt and Bracket System

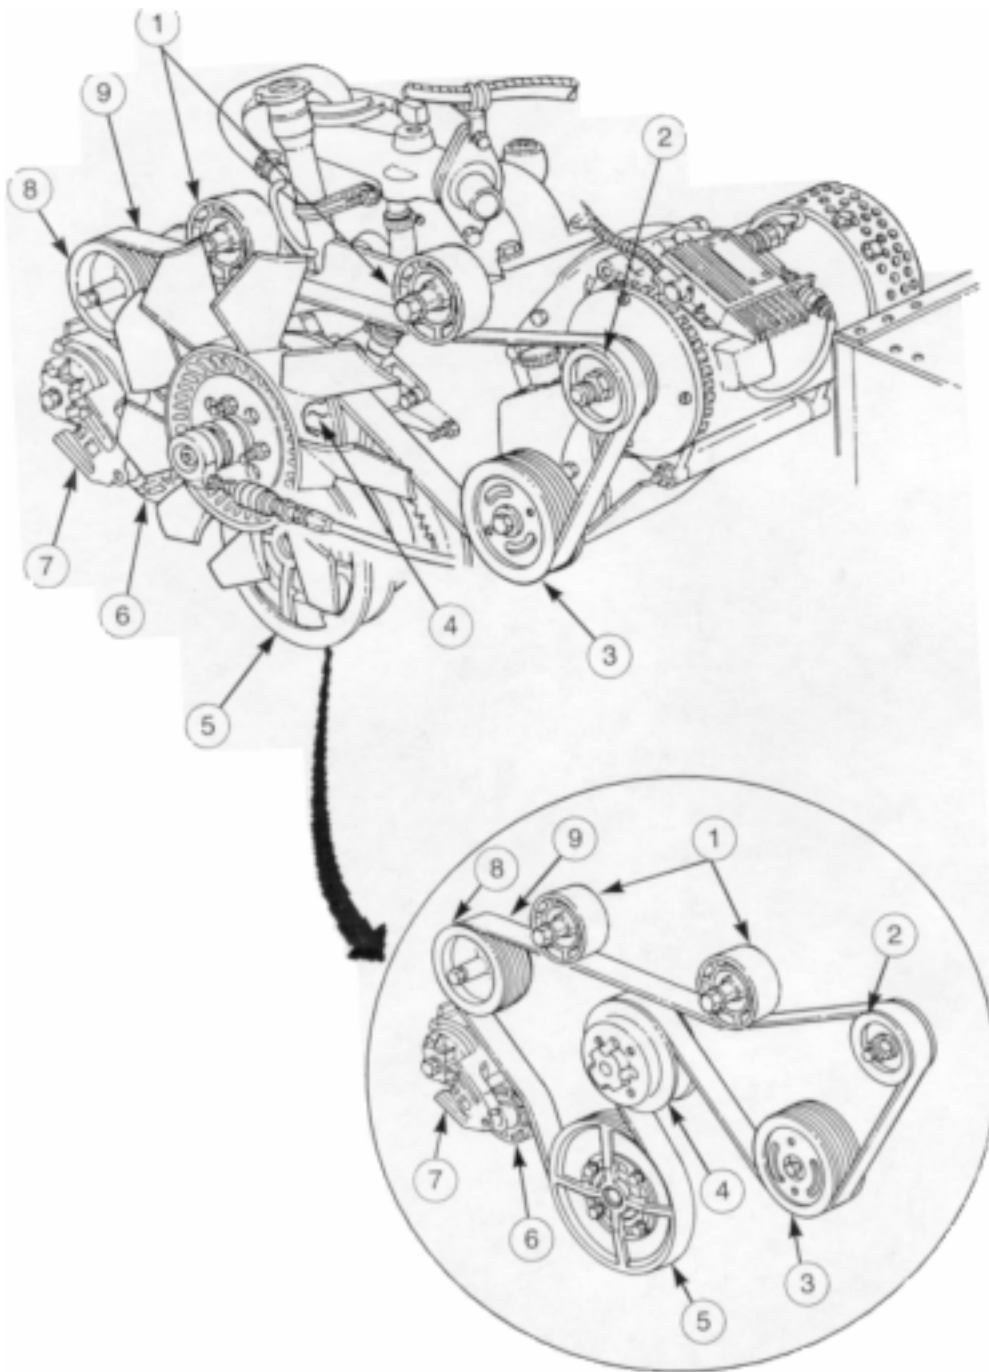
Figure 1

1. Raise and secure hood. (Refer to TM 9-2320-280-10 or TM 9-2320-387-10.)
2. Disconnect battery ground cable. (Refer to TM 9-2320-280-20 or TM 9-2320-387-24.)
3. Install 3/8-in. drive breaker bar on belt tensioner (7) and move tensioner (7) clockwise to loosen serpentine belt (9) as shown in figure 1.
4. Remove serpentine belt (9) from power steering pulley (3), alternator pulley (2), water pump pulley (4), crankshaft pulley (5), air conditioning compressor pulley or idler pulley (8), two upper idler pulleys (1), and belt tensioner pulley (6). Release belt tensioner (7).
5. Check pulleys and pulley grooves for mud or debris. If mud or debris is present, clean pulley grooves with a wire brush.

22. Install serpentine belt (9) as shown in figure 1, and ensure belt (9) engages in all pulley grooves.

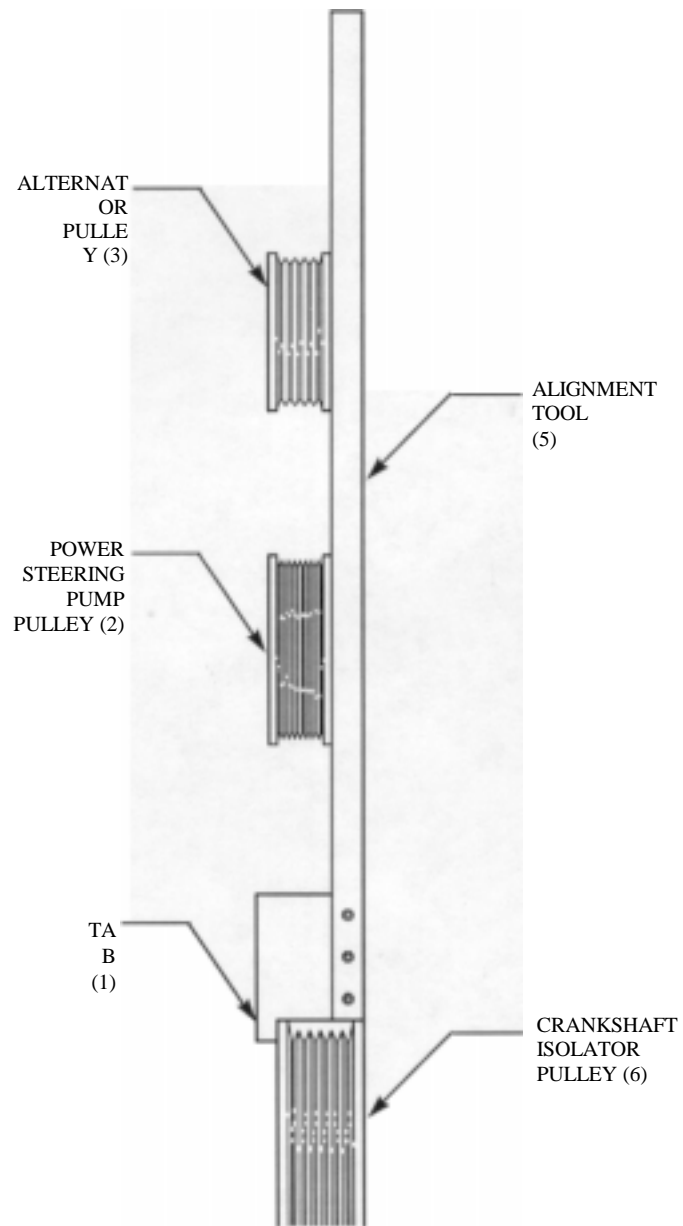
Figure 5

Ensure tab of pulley alignment tool is seated flush against back side of crankshaft pulley as shown in figure 5.

3. Straight edge (4) of tool should seat against power steering pump pulley (2) and alternator pulley (3) as shown in figures 5 and 6. If pulley alignment is flush or meets above note specification, go to step 10. If pulley alignment is not flush, perform steps below.

2. Position tab (1) of pulley alignment tool (5) behind crankshaft isolator pulley (6) and straight edge (4) of tool (5) across power steering pump pulley (2) and alternator pulley (3) as shown in figures 5 and 6.

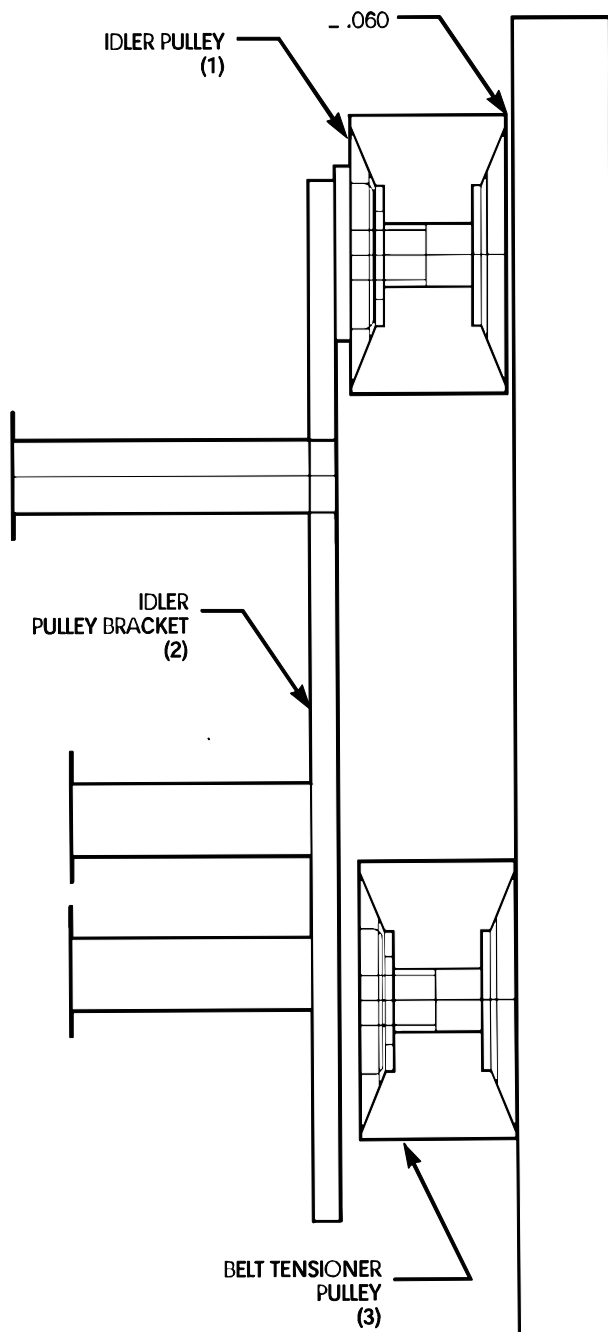
**UPDATED  
CONFIGURATION**  
Figure 12

11. Check idler pulley (1) used on vehicles without air conditioning as shown in figure 12 by removing idler pulley (1). Check that bearing (2) is positioned in center of idler pulley housing (1) as shown in figure 13. Hold idler pulley (1) as shown in figure 14, rotate spacer (2) by hand, and look for side to side movement of spacer (2). Turn idler pulley (1) over and check other side of spacer (2) for movement. Replace idler pulley (1) if bearing (3) is not centered or movement is found on spacer (2).

12. Check two upper idler pulleys (2) and updated configuration idler pulley (3) for loose or noisy bearing, by pushing in and pulling out on idler pulleys (2) and (3) and rotating and listening for noise as shown in figure 12. Replace idler pulley if bearing is loose or noisy. (Refer to TM 9-2320-280-20 or TM 9-2320-387-24.)
